Quality Assurance and Source Inspection

Contract #: 04-0120F4Cty: SF/ALA Rte: 80 PM: 13.2/13.9File #: 1.28**WELDING INSPECTION REPORT****Resident Engineer:** Casey, William**Address:** 333 Burma Road**City:** Oakland, CA 94607**Report No:** WIR-027925**Date Inspected:** 06-Jul-2012**Project Name:** SAS Superstructure**OSM Arrival Time:** 630**Prime Contractor:** American Bridge/Fluor Enterprises, a JV**OSM Departure Time:** 1900**Contractor:** American Bridge/Fluor Enterprises, a JV**Location:** Job Site**CWI Name:** Andrew Keech**CWI Present:** Yes No**Inspected CWI report:** Yes No N/A**Rod Oven in Use:** Yes No N/A**Electrode to specification:** Yes No N/A**Weld Procedures Followed:** Yes No N/A**Qualified Welders:** Yes No N/A**Verified Joint Fit-up:** Yes No N/A**Approved Drawings:** Yes No N/A**Approved WPS:** Yes No N/A**Delayed / Cancelled:** Yes No N/A**Bridge No:** 34-0006**Component:** S.A.S. Components**Summary of Items Observed:**

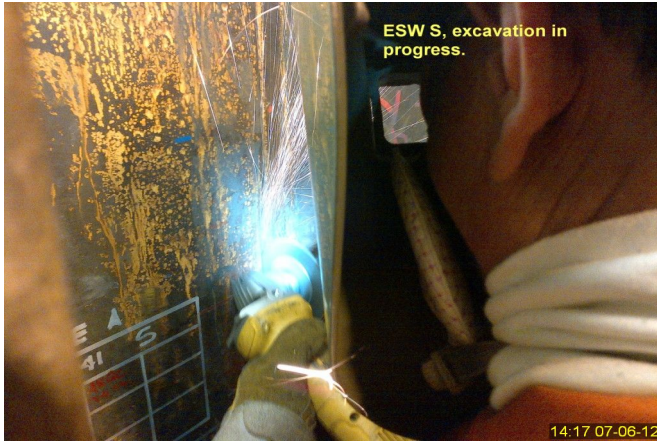
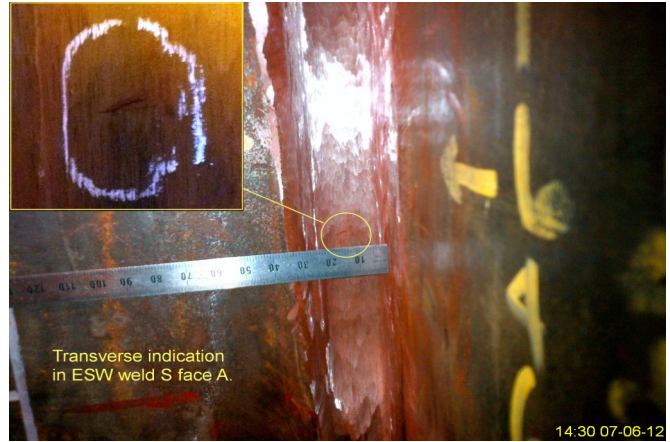
The QAI met with Quality Control Inspector (QCI) Andrew Keech. The QAI and the QCI were informed that several indications reported from surveying ESW weld S (S-041). The QAI and QCI reviewed the areas and noted that one of the indications was transposed with the incorrect Y location. The QAI and the QCI determined the Y location to be 7540mm. The QAI and the QCI witnessed the excavation of the indication. At 2mm depth intervals the excavated weld was visually examined and magnetic particle testing (MT) was performed by the QCI. The QAI noted that at 16mm deep, there was a 5mm transverse indication observed with MT. The QAI Robert Mertz, the Structural Materials Representative (SMR) Aaron Prchlik and the contractor's Welding Quality Control Manager (WQCM) Jim Bowers were present and observed the indication. See the attached photos. Additional grinding was performed and the area was re-examined with MT. There was no indication visible at an excavation depth of 18mm. The QAI was informed that additional areas will be excavated. This work was in progress at the end of the shift.
